DDOT Experience with Rectangular Rapid Flashing Beacons

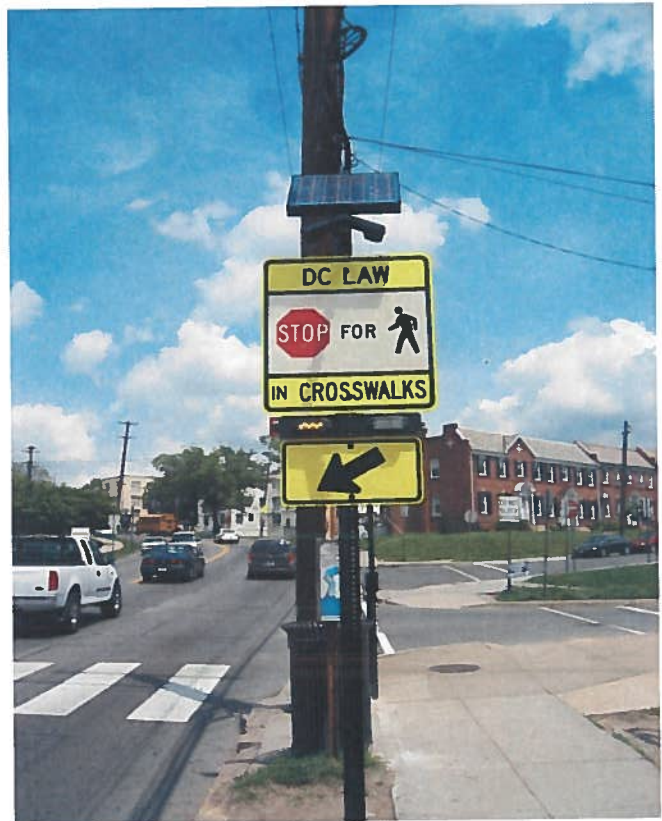
RRFB installed at Brentwood Rd. NE.

- Since 2008, DDOT has installed a new type of crosswalk beacon, called a “Rectangular Rapid Flashing Beacon,” or RRFB, at several locations to alert drivers approaching the crosswalk that pedestrians are in or about to enter the crosswalk.
- This new beacon features two solar powered pedestrian activated high-intensity amber LED beacons that flash only when a pedestrian needs to cross. The beacons flash in an attention-getting stutter pattern.
- Advance stop lines accompany the RRFB on multi-lane streets. These stop lines promote drivers to stop further back from the crosswalk so that if a driver in the other lane does not stop, the pedestrian can see the approaching vehicle.
